### RIB-T7 – Personal Accident, August 25, 2016

S-48/17

#### **RIB-T7 SFD-2170**

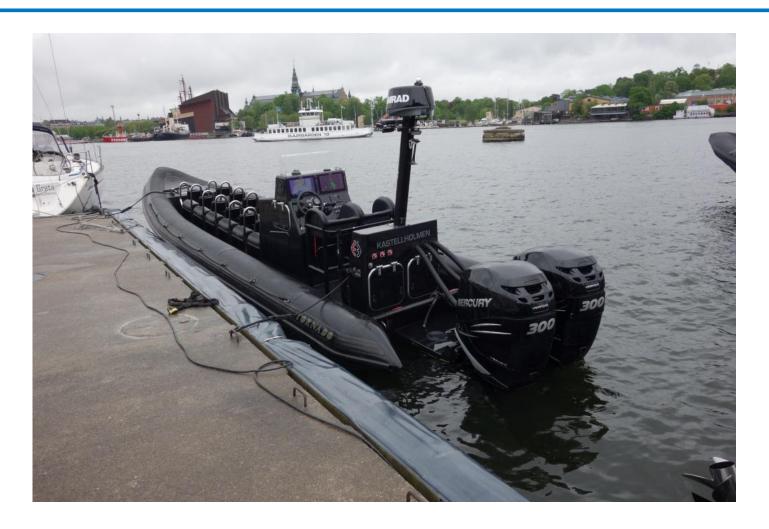
### Vessel

- RIB-boat
- L 9,5 meter
- B 4,6 meter
- Draft 0,5 meter
- Built 2013
- Engines 2 petrol-driven outboard, 600 hp
- Speed abt 60 knop = abt 110 km/h
- Max 12 pax

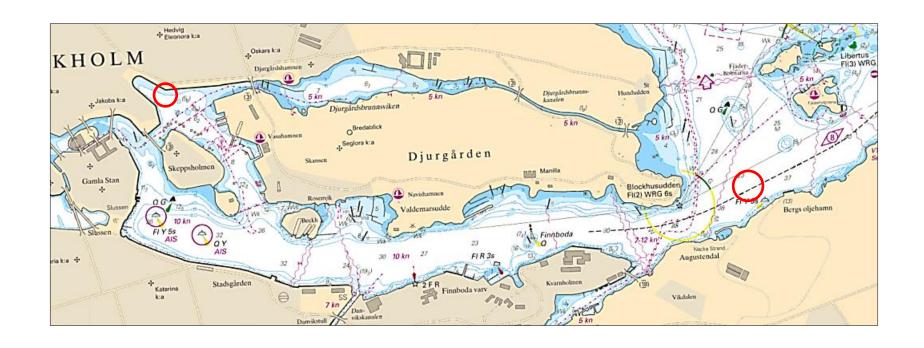
#### Scene of the Accident

- The RIB boat met the first wave well, in the second wave a "snatch" (bump laterally) came.
- The landing was a little skewed, and for the persons on board there was a jerk both horizontally and vertically.
- Estimated the speed 35 knots when they met the first wave and the free fall at the forward part of the boat to about two meters.
