THE MARINE ACCIDENT INVESTIGATION BRANCH

Chief Inspector of Marine Accidents

Motion induced injuries

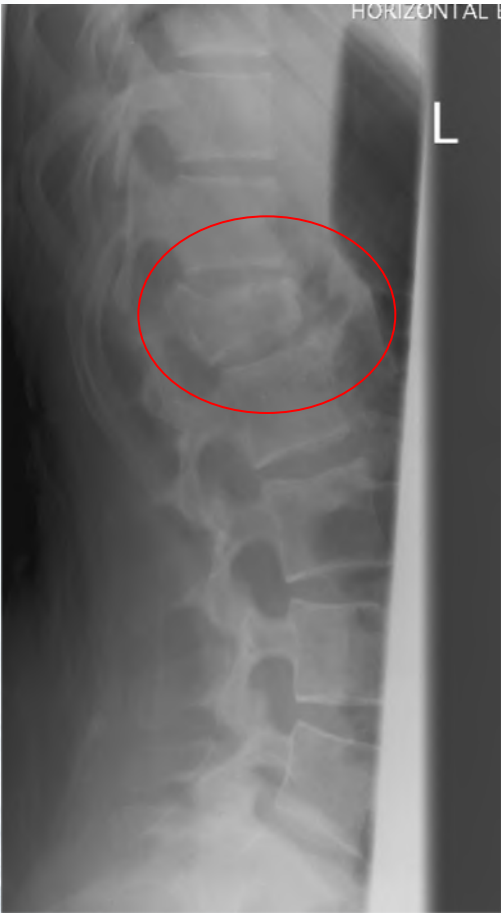
Characteristics

- Boat impacts water heavily as a result of travelling too fast in prevailing conditions, or deliberate wave / wake jumping.

Passengers in unsuitable seating suffer compression fractures to the lower spine (L1-L3). Younger passengers generally recover, but older passengers and those with pre-existing spinal conditions can be permanently disabled.

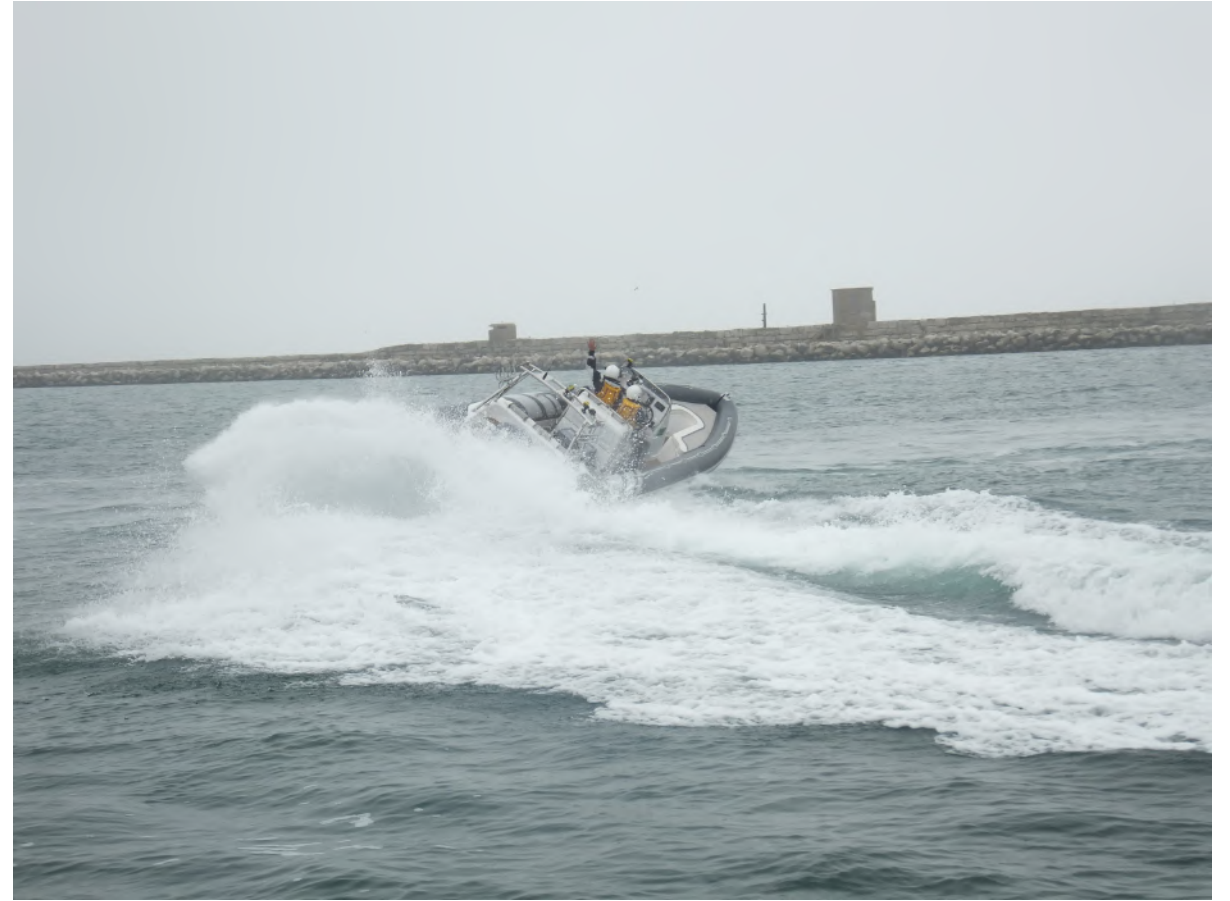
Falling overboard

- Passenger falls or is ejected from the boat due to violent motion in prevailing sea state, wave wash-over, slamming, spin-out / hook.

Passengers get wet and suffer minor bruising / abrasion UNLESS hit by returning boat, when head and upper body injuries most likely, but all parts of the body can be impacted. PIW hit by fast moving propellers likely to suffer severe injuries or death.

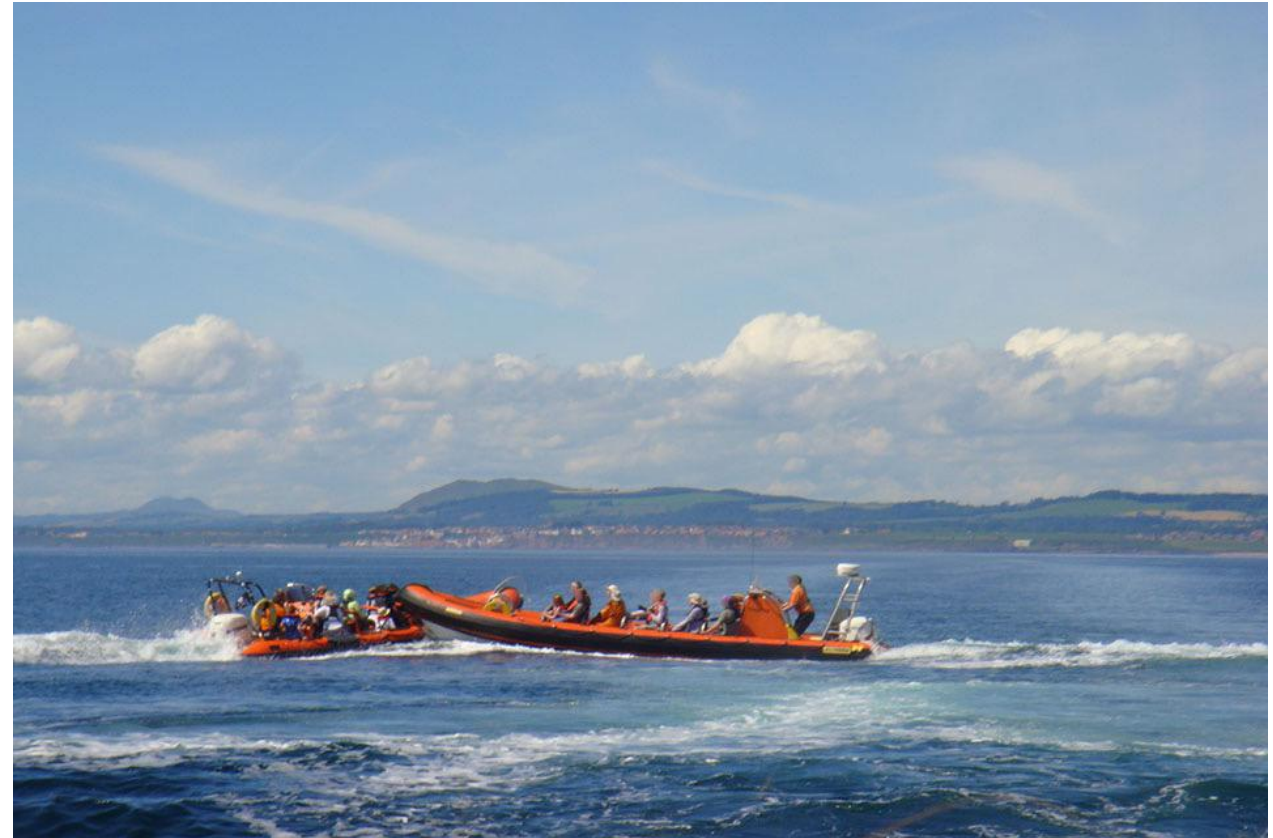
Osprey I & II – low speed collision, 19/7/2016

Victim - 45 yo Female

2 broken collar bones

5 broken ribs

Punctured lung

Laceration and bruising to back & torso

Induced coma for 3 weeks

Permanent damage to sight in both eyes

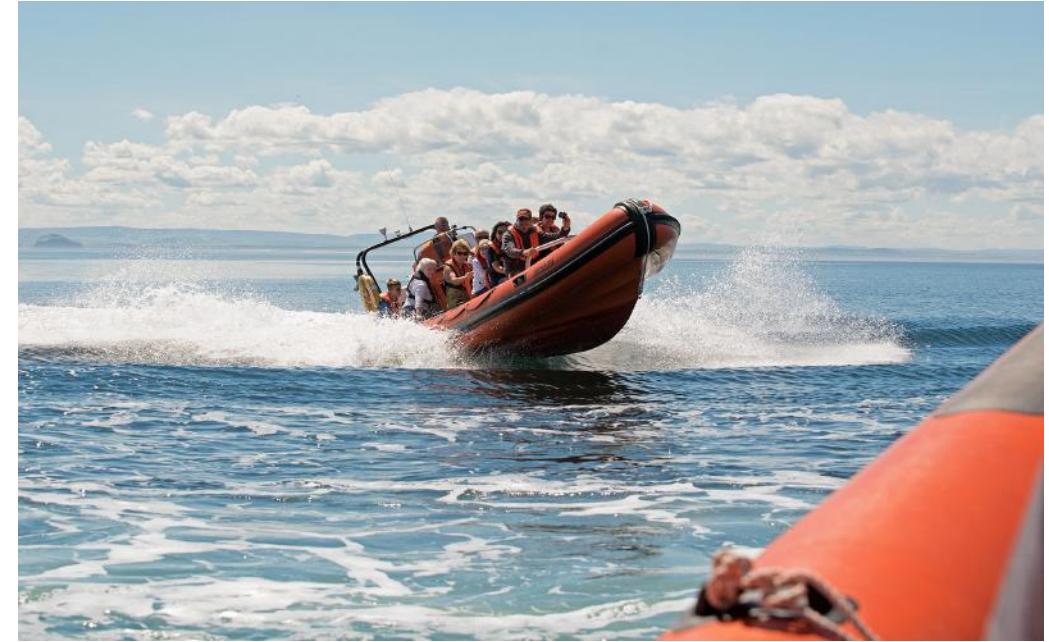
Side impact collision

- Impacting craft rides up over the other vessel and at higher speed can completely cross it.
- Passengers in the impacted craft can suffer upper body and head injuries, including death.

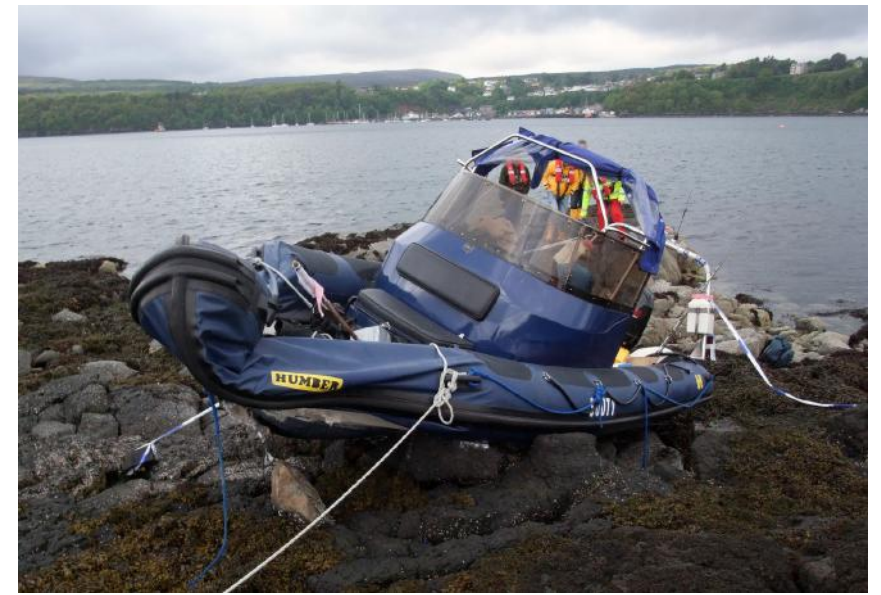
Head-on collision with a stationary object

- Impacting vessel either rides up and potentially over the stationary object, and / or suffers rapid deceleration either from impact or loss of power.
- Passengers are thrown forward into the craft's structure and can be ejected from the craft over the bow.
- Passenger injuries are consistent with road traffic head-on collisions: head and facial injuries, impact injuries to upper torso and upper limbs. Injuries can result in death.
