HSBO Forum June 2025

Accident on a RHIB: Why research on shock impacts is important

CDR (MC) / OF-4 Dr. med. Kai-Thorsten Bretschneider (KT)
Internal and Occupational Medicine

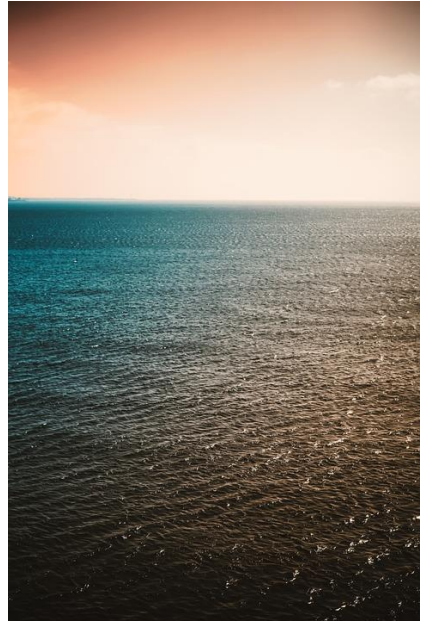
- The boat was launched on the port side, turned 270° to the left and was **crossing the stern wave** of the MVP from its port side to its starboard side around 100 m behind the ship. The boat captain reduced the speed (unknown, estimated 10-12 kn).
- The boat was **lifted out of the water and landed hard** in the trough, making it impossible for the sailor to hold on and remain seated. He was initially thrown upwards. As he moved downwards, the boat was already moving upwards again, so that **the impact was amplified**.
- The sailor secured himself by holding onto the designated ropes. Whether he used the designated foot loops could not be determined. He landed with his **tailbone on the cleat**.

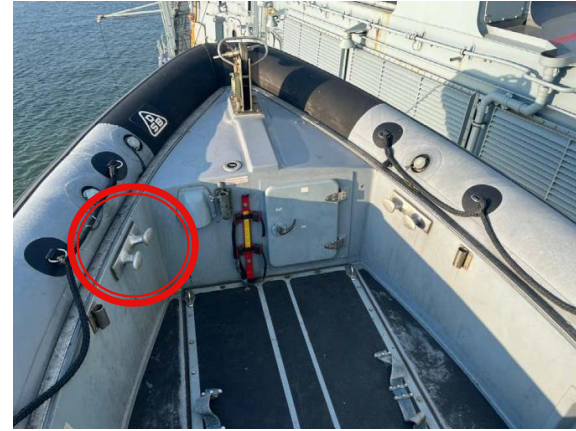
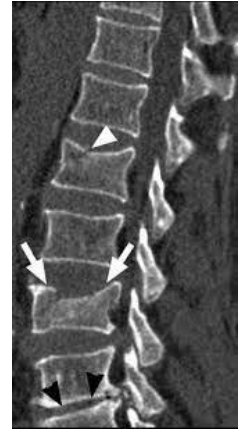
- First Aid by the security officer
- Transport to the frigate MVP
- Examination by the ship`s doctor
- Transport by on-board helicopter under medical supervision to Klaipeda Hospital
- Further diagnostics: Compression fracture in the lumbar spine
- Transferred to the Bundeswehr Hospital Koblenz three days later for further treatment
