THE MARINE ACCIDENT INVESTIGATION BRANCH

Chief Inspector of Marine Accidents

Motion induced injuries

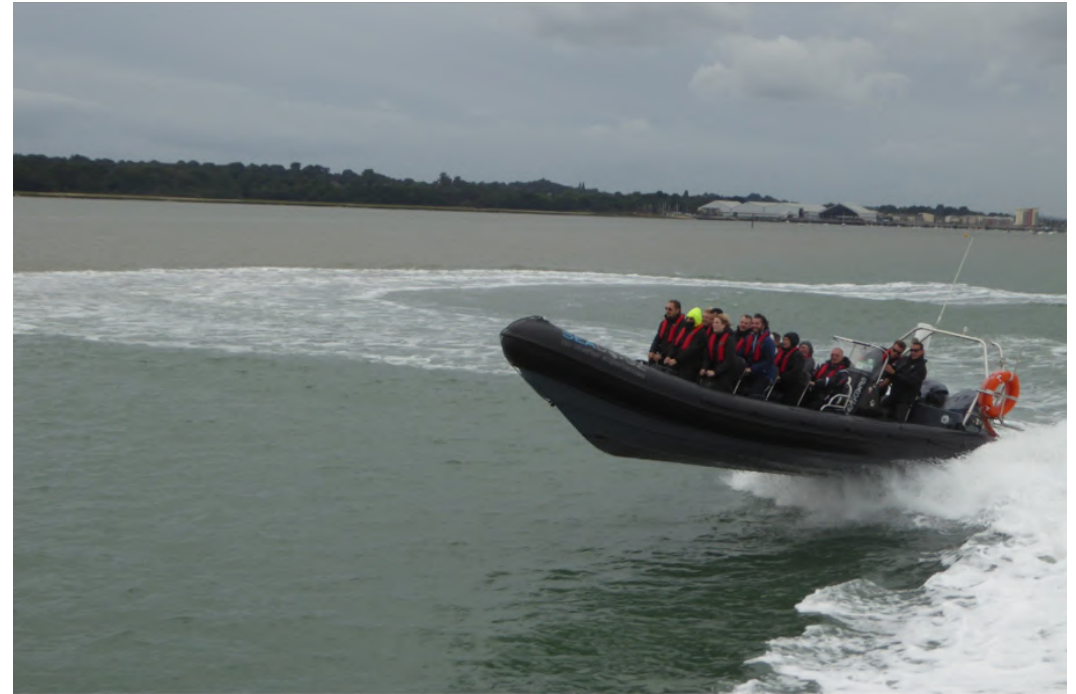
- Boat impacts water heavily as a result of travelling too fast in prevailing conditions, or deliberate wave / wake jumping.

Passengers in unsuitable seating suffer compression fractures to the lower spine (L1-L3). Younger passengers generally recover, but older passengers and those with pre-existing spinal conditions can be permanently disabled.

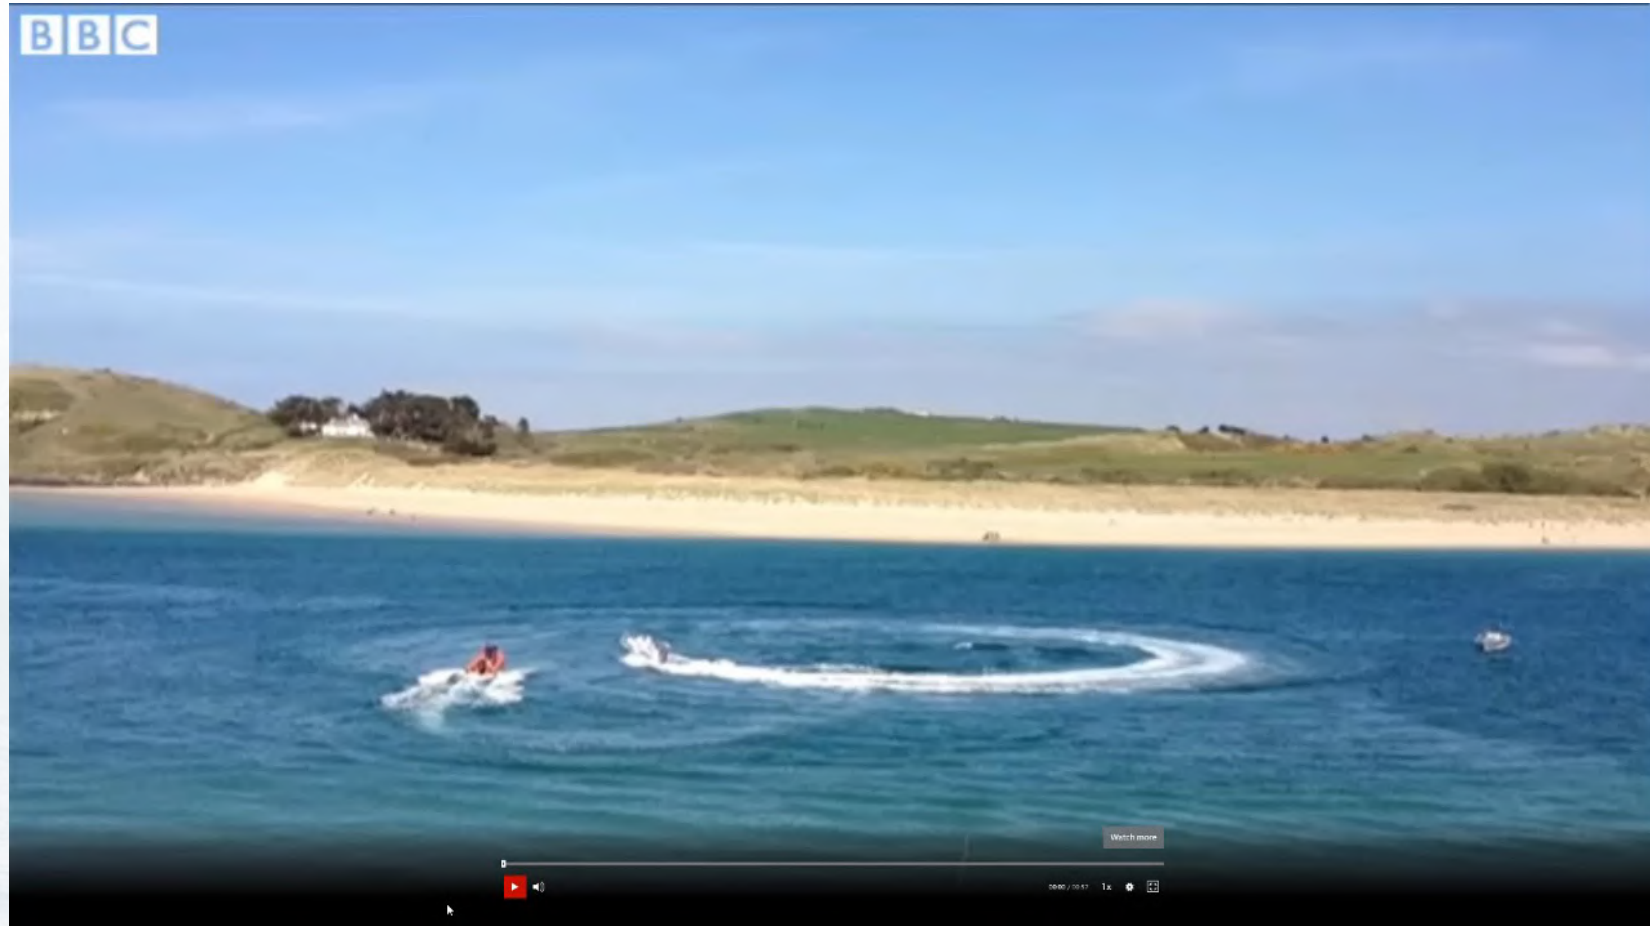
Falling overboard

- Passenger falls or is ejected from the boat due to violent motion in prevailing sea state, wave wash-over, slamming, spin-out / hook.

Passengers get wet and suffer minor bruising / abrasion UNLESS hit by returning boat, when head and upper body injuries most likely, but all parts of the body can be impacted. PIW hit by fast moving propellers likely to suffer severe injuries or death.

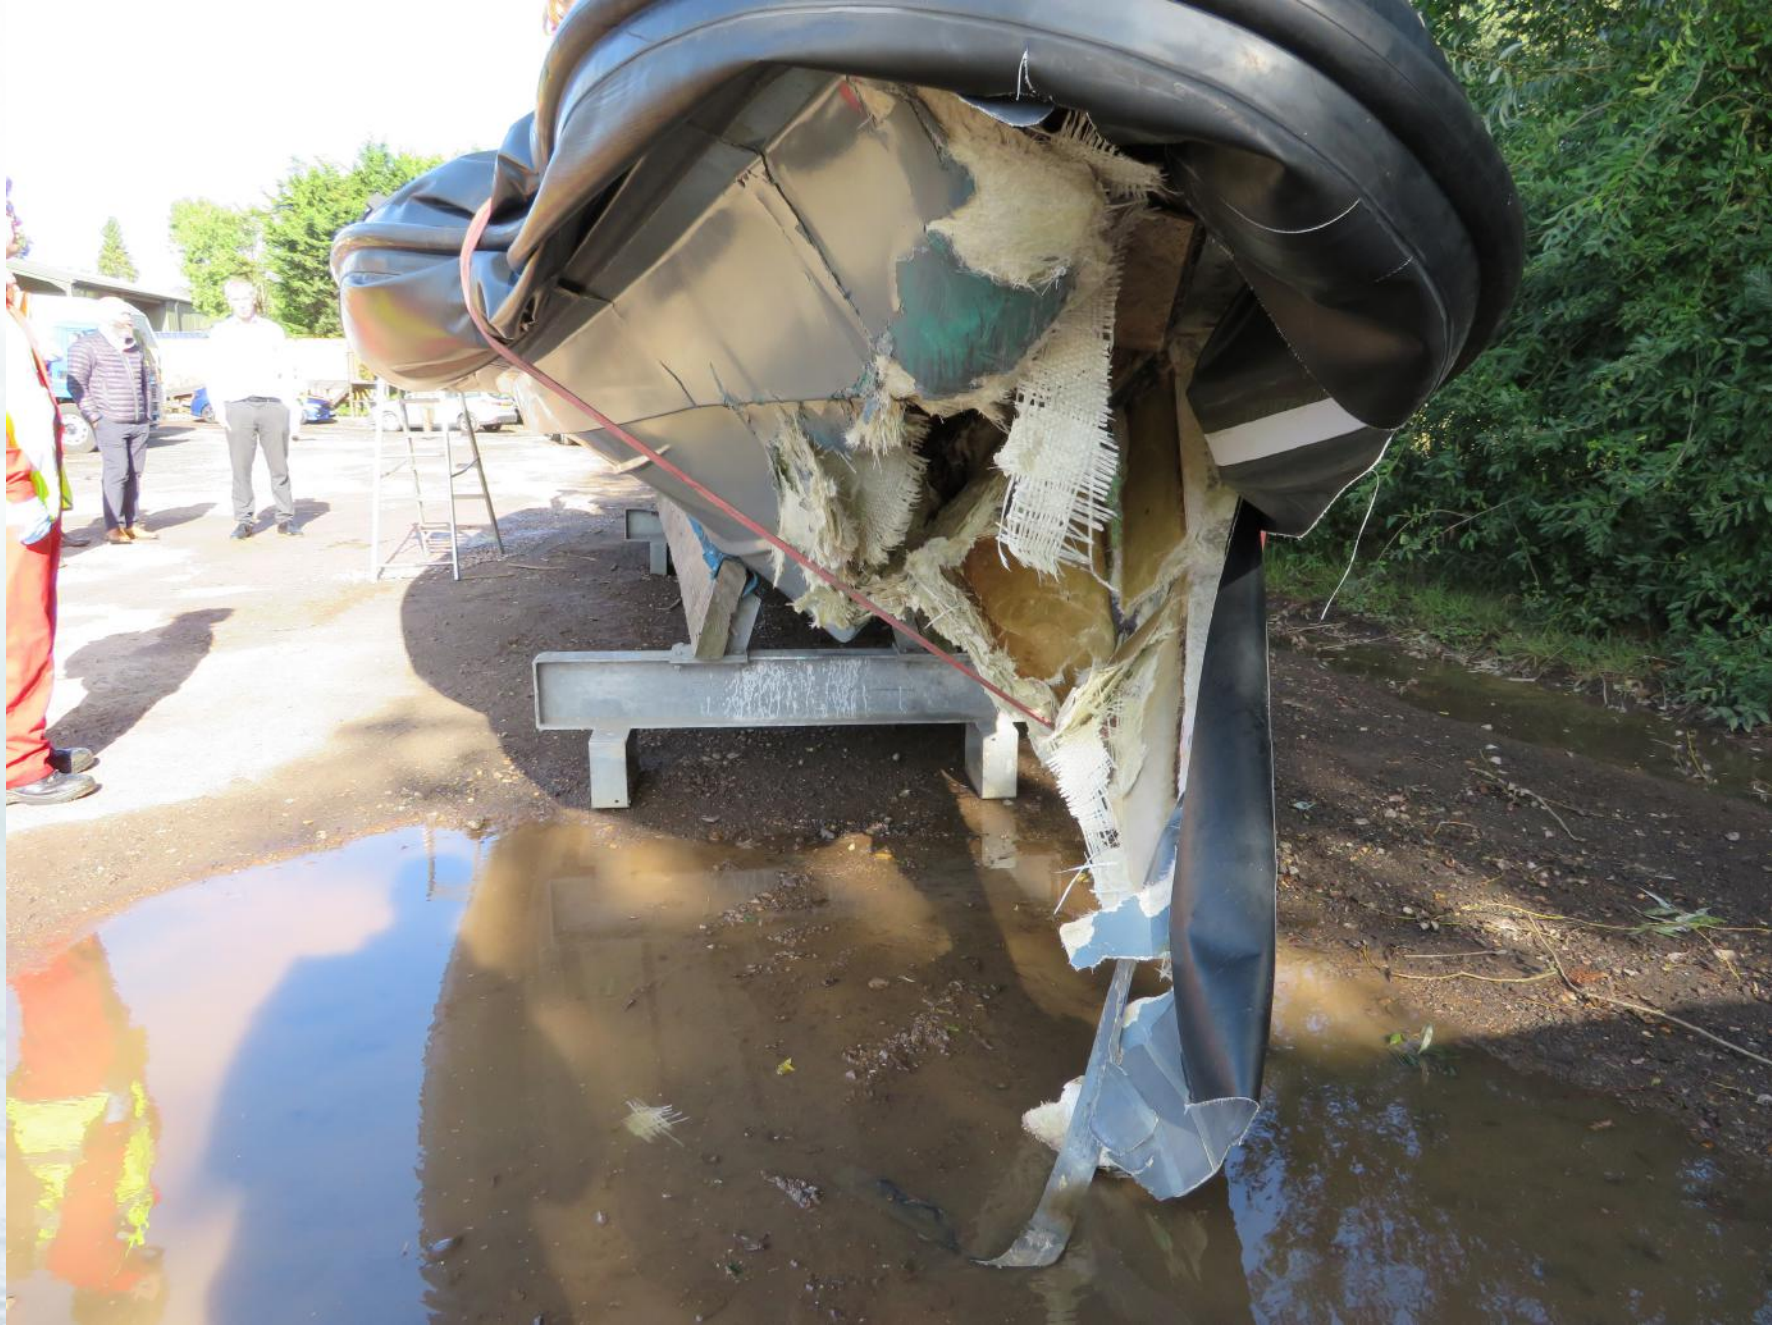
Head-on collision with a stationary object

- Impacting vessel either rides up and potentially over the stationary object, and / or suffers rapid deceleration either from impact or loss of power.
- Passengers are thrown forward into the craft's structure and can be ejected from the craft over the bow.
- Passenger injuries are consistent with road traffic head-on collisions: head and facial injuries, impact injuries to upper torso and upper limbs. Injuries can result in death.
