HSBO Forum June 2025

Accident on a RHIB: Why research on shock impacts is important

CDR (MC) / OF-4 Dr. med. Kai-Thorsten Bretschneider (KT)
Internal and Occupational Medicine

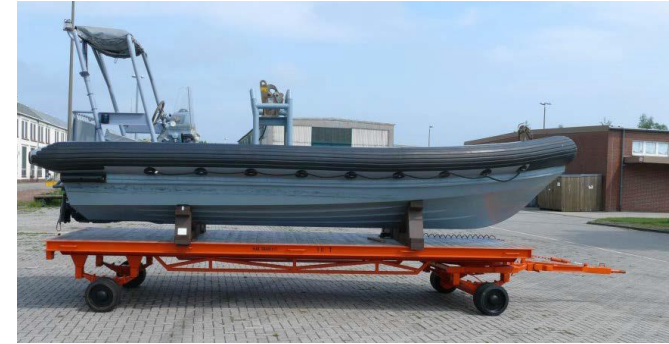
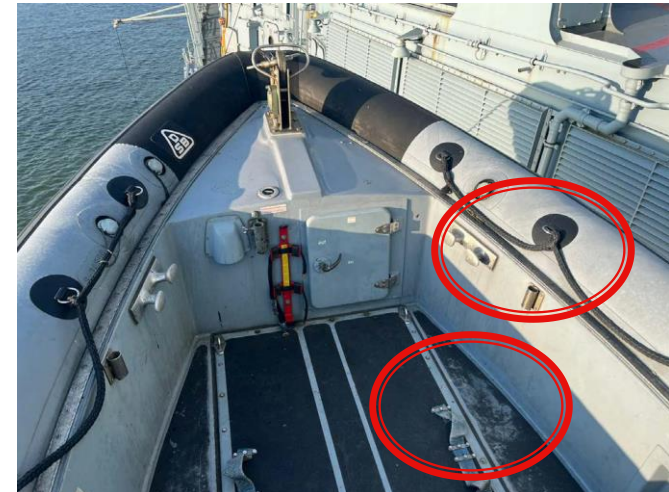
Fast Rescue Boat FRB 700/Bw-2

- Designed as „rapid crisis response and emergency boat”
- Complies with specifications SOLAS Chapter III 41, 42, 47
- Length 7,10 m, width 2,54 m, weight 2,1 tons (incl. fuel)
- Engine 147 kW/200 hp, speed max 30 kn (2 persons)
- Crew 2-6 persons (FRB):
 - 1 seat for the helmsman/skipper
 - crew members: all-round tube fender with ropes and foot straps
- The crew consisted of skipper, security officer and sailor.

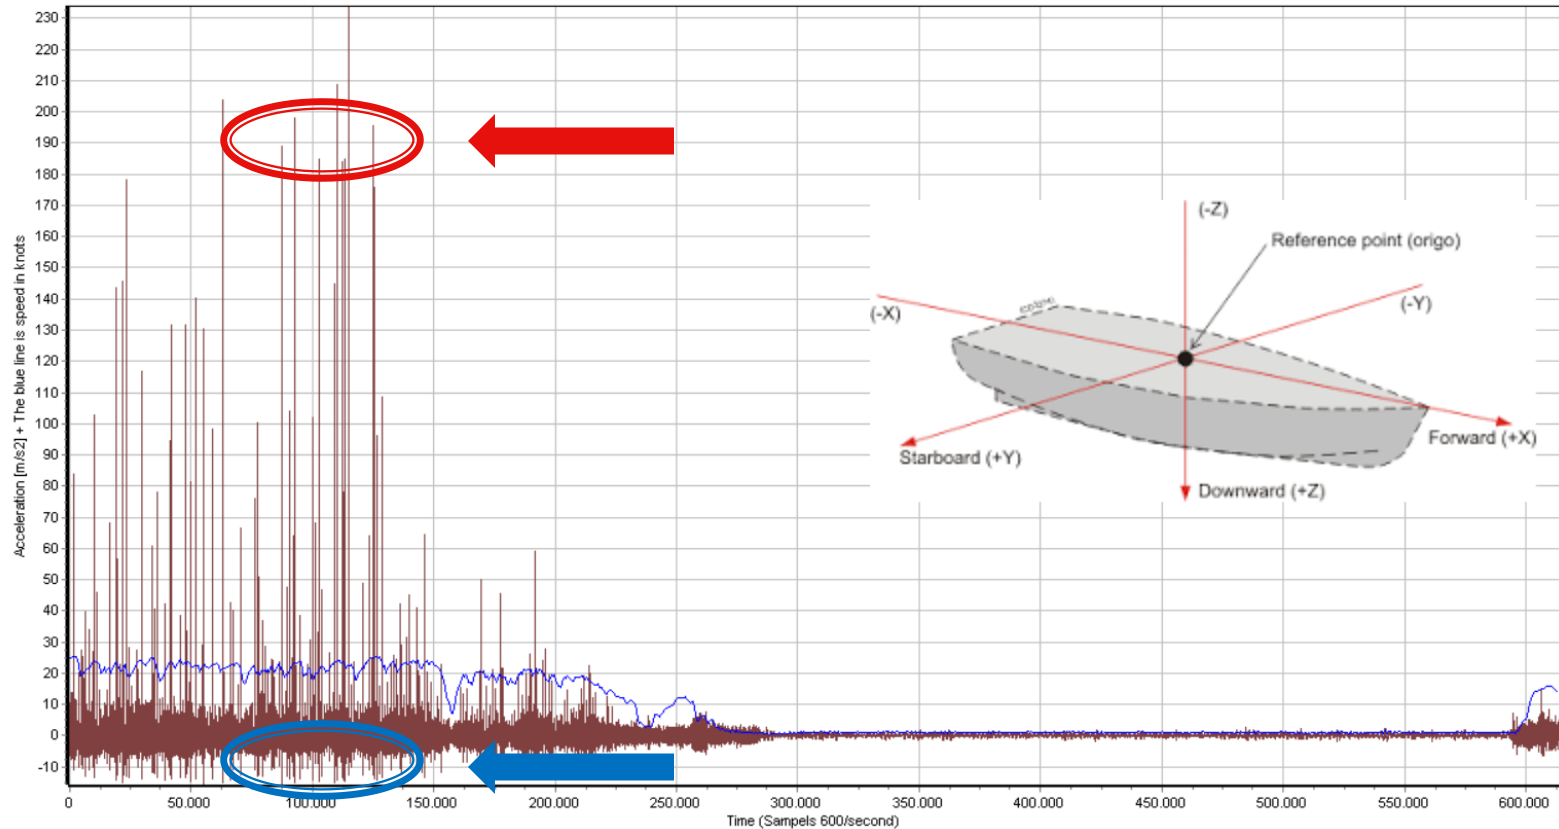
C:\Users\SMIM\Desktop\1. Seefahrt\Boot M 18\24102103.DAT (10 channels) Ser.no 0033 Sample start time 11:30:47

- Understanding of the forces acting through shock impacts and their effects:
 - 10-15 kn → Compression fracture in the lumbar spine
 - 30 (+) kn → Musculoskeletal system, Central nervous system...?!
 - **Need for follow-up studies** after ending RTG-344
- Training of boat operators with user manuals based on the evaluation of load and stress data and the knowledge of accidents.
- **No procurement and no use of (military) RHIBs without suspension seats or comparable safety devices for all crew members.** (DEU Naval Institute of Maritime Medicine 03/2025)
